Manhole Inspection Summary

Manhole # S53O__024MH

Insp Date: **4/18/08 8:59 AM**

Location Address: **3120 odonnell street**

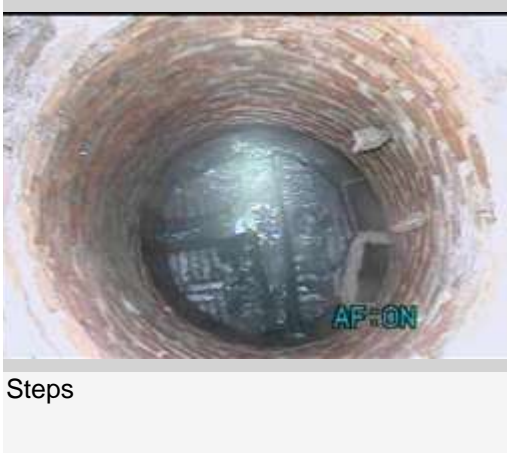
Defect 1

Count: **6** Missing: **1** ☒ **Corroded**

Steps

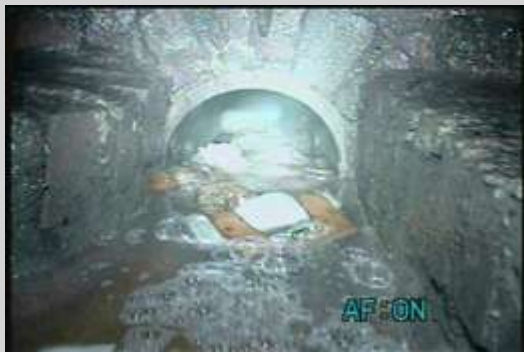
12 O'Clock Outflow

8 in. Circular Gravity Sewer
Pipe Out @ 12 OClock

Deposits: ☐ None ☐ Mud ☐ Sludge ☒ Debris ☐ Grease

Silt Depth: 5 (in.) Deposits Extent: Heavy

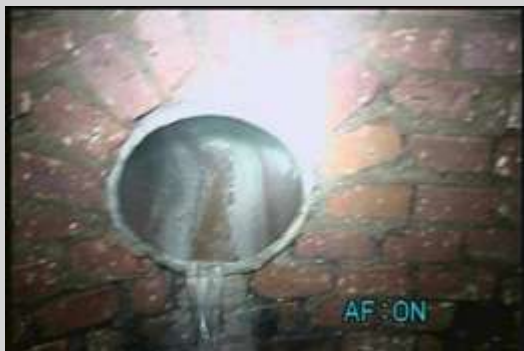
6 O'Clock Inflow

8 in. Circular Gravity Sewer
Pipe In @ 6 OClock

Drop In @ 6 OClock

Drop: Outside Direct

Drop Condition: Open

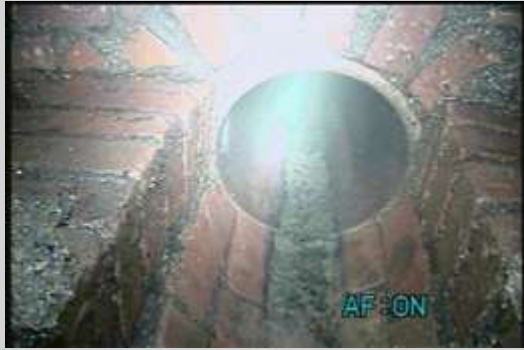
9 O'Clock Inflow

8 in. Circular Gravity Sewer

Pipe In @ 9 O'Clock
